**Seed
Environmental**

Case Studies

Agricultural Fire in Berkshire

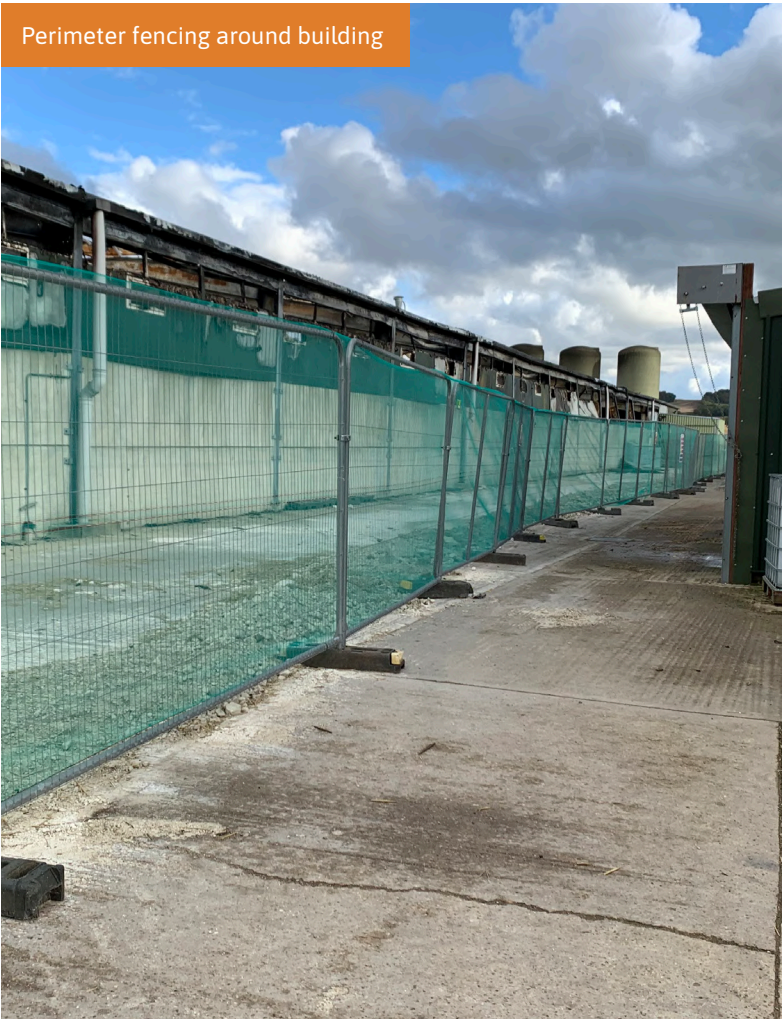
Perimeter fencing around building

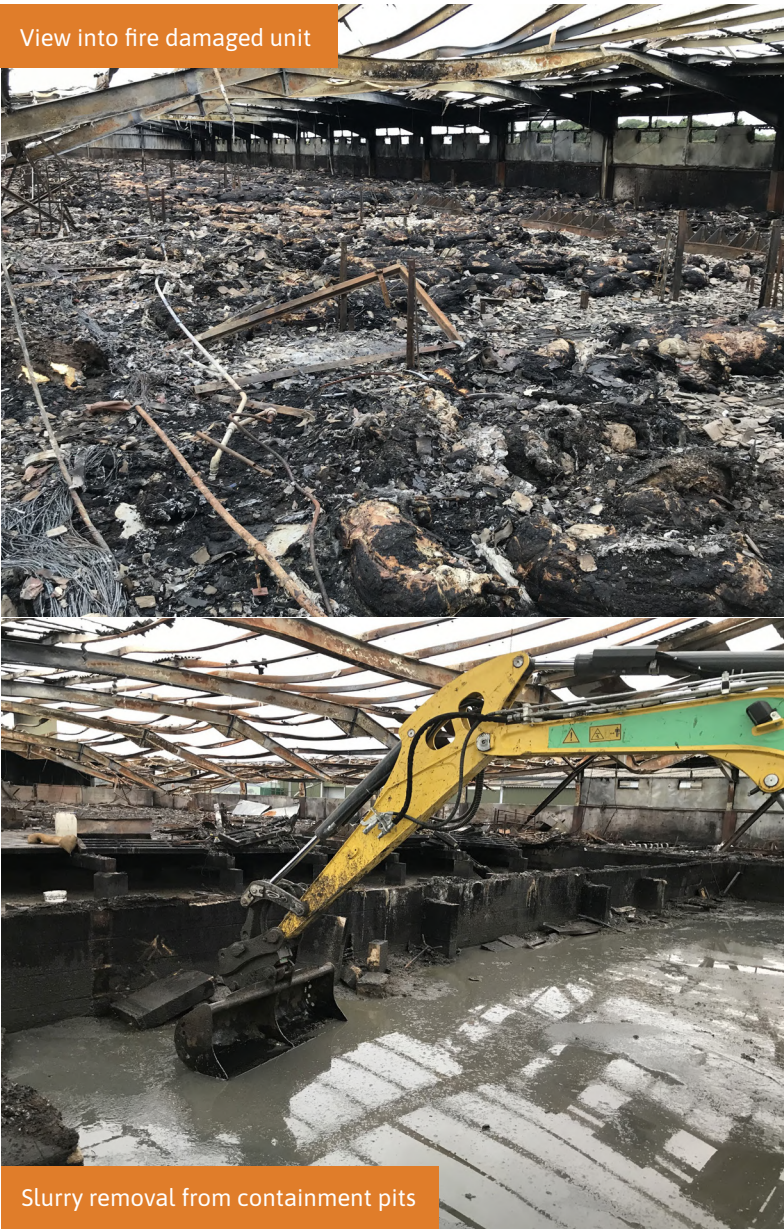
View into fire damaged unit

The fire had killed all of the livestock held within the unit, in places the heat from the fire had cracked the external walls of the slurry containment pits, the steel frame had warped, twisted and dropped, the roof collapsed into the building bringing with it the roof mounted solar panels which degraded in the fire and released heavy metals into the slurry below and in places the floor had melted resulting in some of the animal carcasses falling into the slurry. With other livestock present in close proximity to the fire damaged unit an additional concern was the risk of disease spreading from the decaying carcasses.

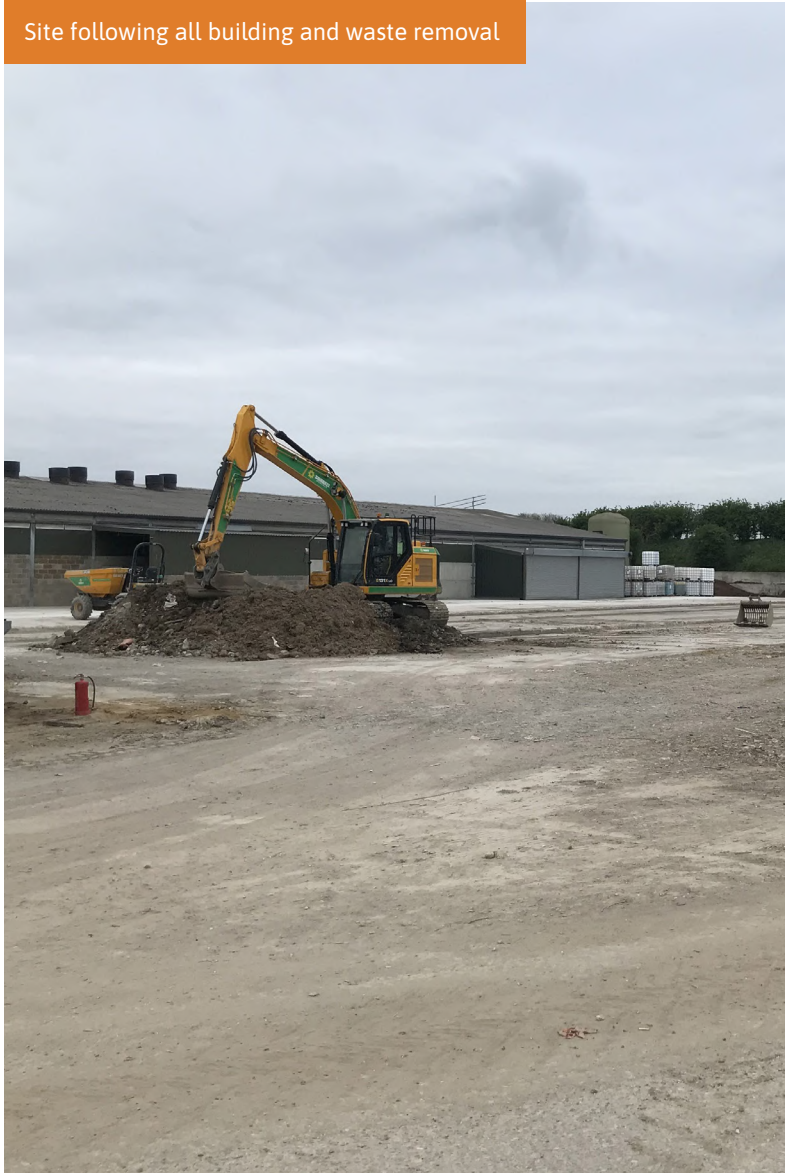
Site following all building and waste removal

The building was not deemed structurally safe. Therefore temporary bracing was fitted to areas of concern to reduce the risk of uncontrolled slurry loss and consequential wider environmental problems and to ensure the area was safe to work in. Carcass removal proceeded as soon as it was deemed safe to proceed with the waste leaving site for incineration. In unison with these works a slurry holding lagoon remote from the building had its exiting contents moved to another yard of the farm to enable the slurry beneath the damaged building to be transferred to safer containment in the unaffected lagoon. Following carcass and slurry removal the remains of the building were dismantled and recycled / disposed as appropriate. Disposal solutions for the slurry were sought. This was a challenge because it represented a mixed waste with the slurry containing animal body parts and heavy metals. The hunt for a solution involved DEFRA, the EA and the Welsh Government and the final solution involved the EA allowing some of its usual rules to be bypassed. The eventual solution required the slurry to be transferred to sealed drums for transportation to a waste treatment facility for licensed processing. Following completion of carcass and slurry removal and full demolition of the building the site was handed back to the farm whom with assistance from insurers appointed their usual contractors to erect a new unit.
