**Seed  
Environmental**

**Case Studies**

Flooded factory in Norfolk

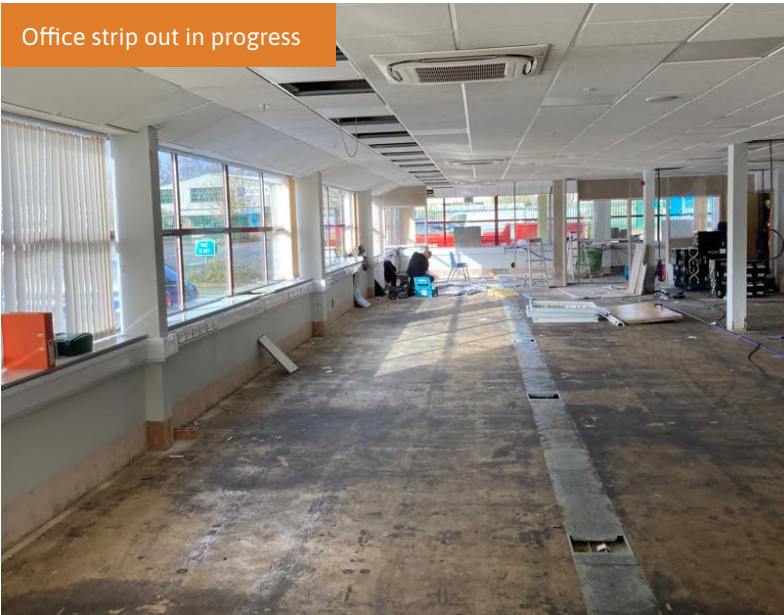
Office strip out in progress

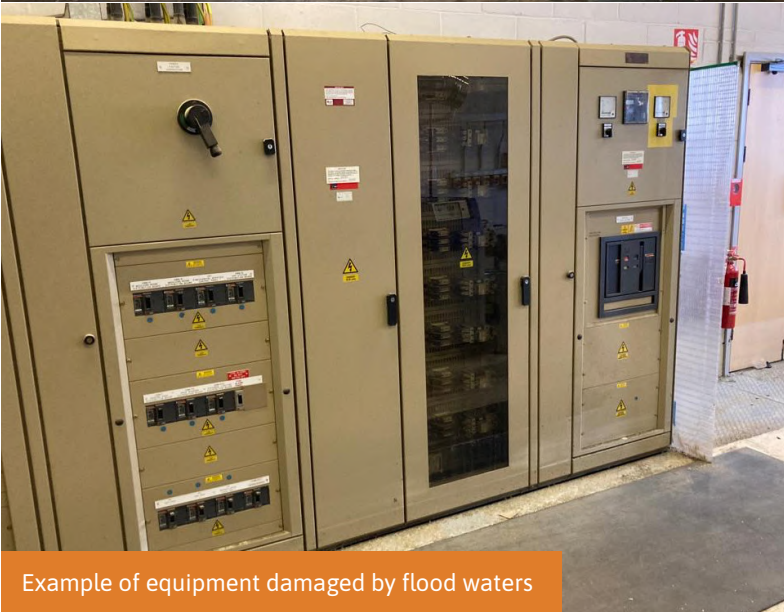
The flood waters entered both the offices and workshop of the premises. Severe damage in and around the workshop was sustained to industrial compressors and air conditioning units which were set at ground level, with some damaged beyond repair. Within the office all floor coverings and electrical wiring which was all located in floor ducts throughout were damaged along with internal partition walls and skirtings. In addition the substation serving the property was also damaged.

Example of equipment damaged by flood waters

Following completion of the building being dried and cleaned by others, Seed Environmental compiled a robust program of works to electrically test the existing wiring and infrastructure, subsequently repairing or replacing as required. As part of reinstatement works all wiring and infrastructure was either raised to 1m above floor level or flood protected to future proof the building from the same extent of damage should it ever flood again. Works also included replacement of internal walls, skirtings, doors, floor coverings too damaged to repair. Emphasis was on completing the works with no delays, so that the occupant could return to production as quickly as possible, enabling them to start supplying their clients again and to minimise the business interruption claim. In addition, Seed managed the process of liaison with UKPN to arrange for repair/replacement of the substation.

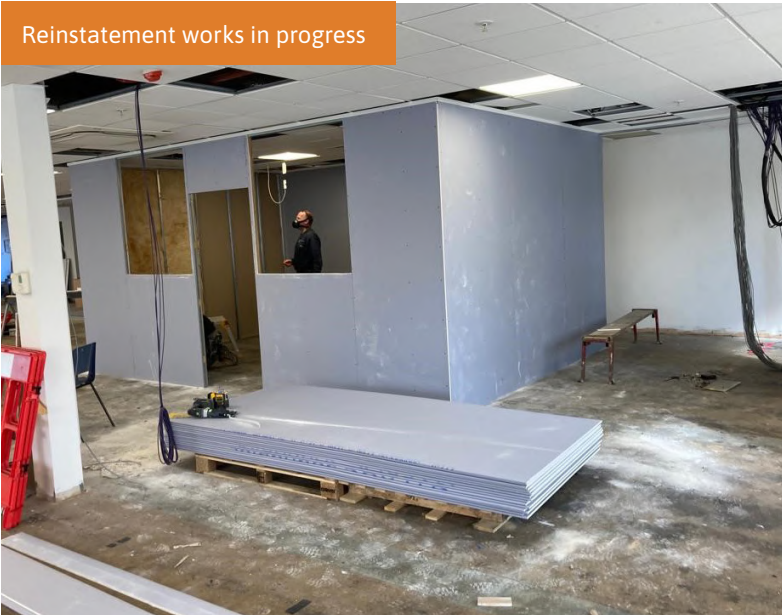
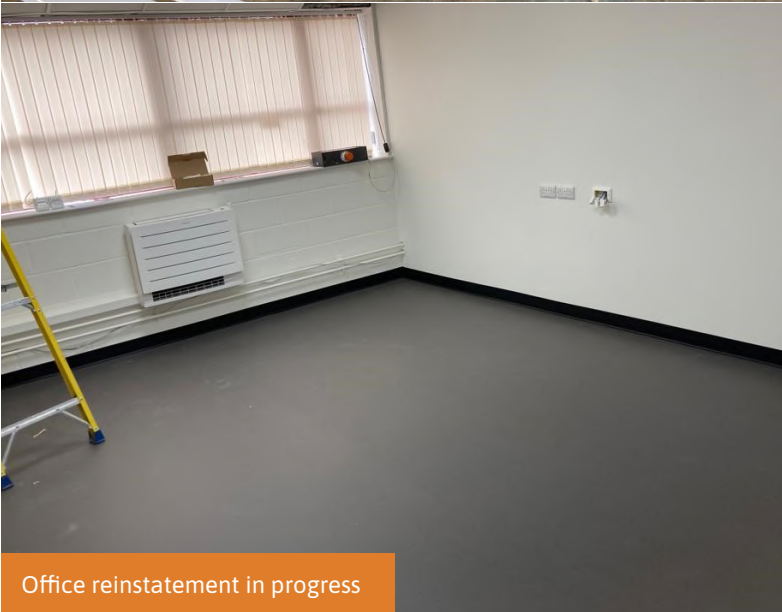
Reinstatement works in progress

Office reinstatement in progress

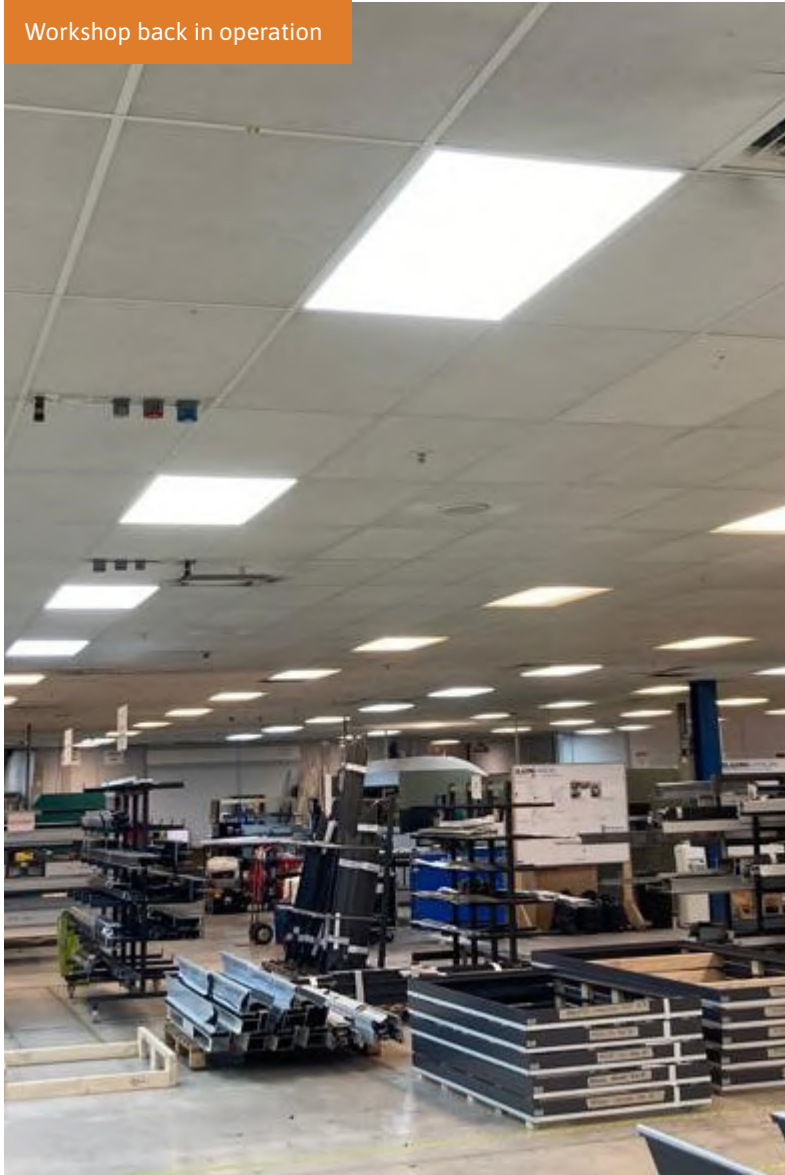
Workshop back in operation
